Heading Issues

Published on Greensea Knowledge Base (<http://localhost:8888/kb2017>)

Article ID: 192

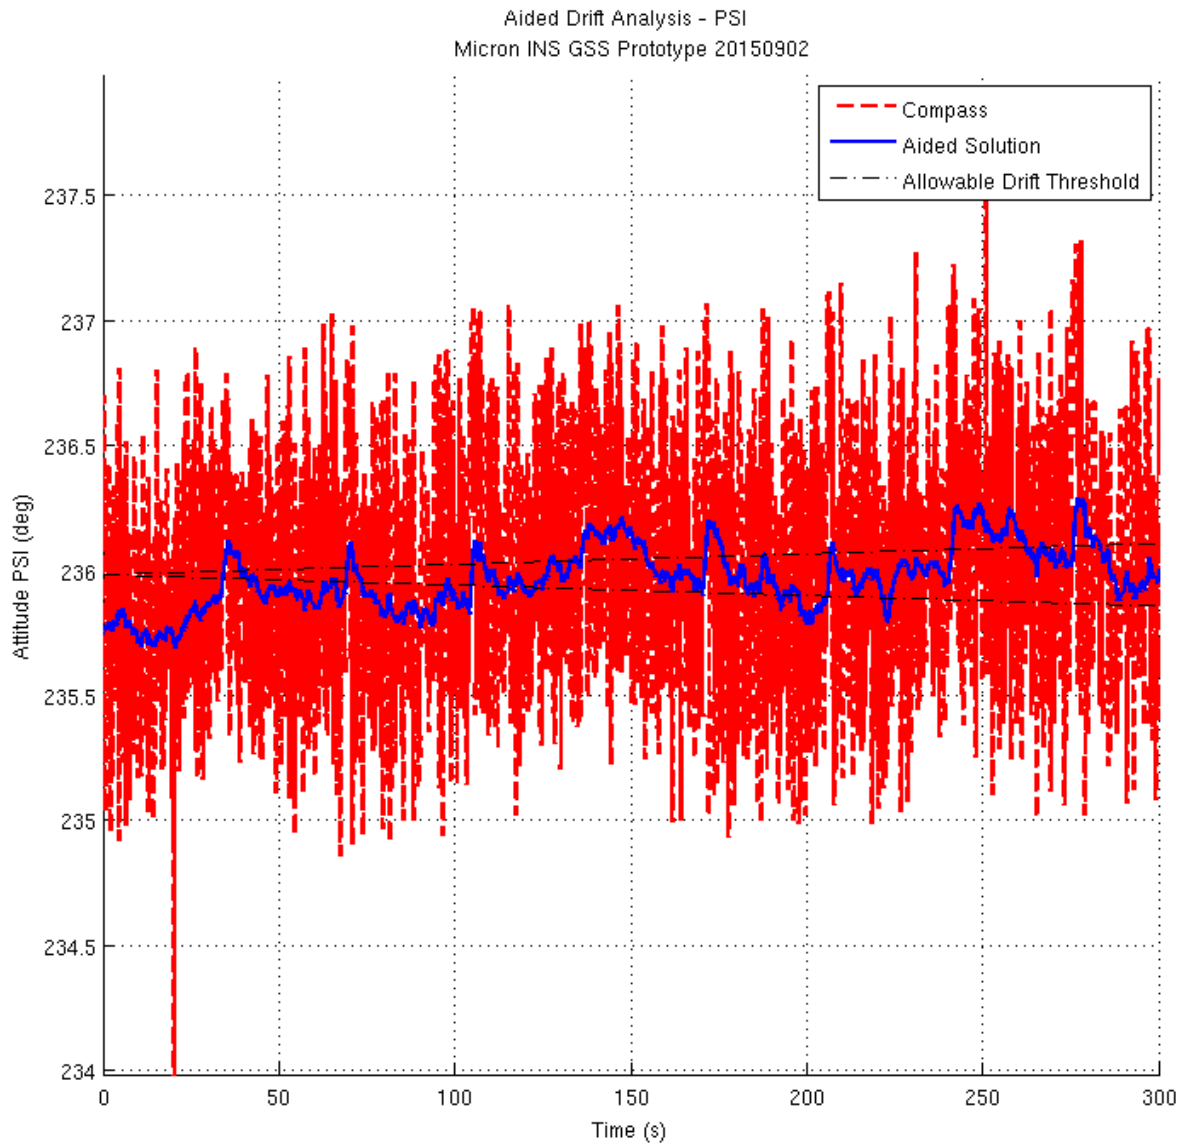
Illustration 1:

- **Oscillating heading.** An INS that uses a magnetic sensor as an aiding heading input may experience an oscillating heading if the magnetic sensor is oscillating or if the gyro has significant noise. An oscillating heading more than a 1 degree peak-to-peak is pretty uncommon unless there is a sensor fault. For MEMS-based gyros aided by a magnetic heading sensor, a heading oscillation less than 1 degree peak-to-peak is not that uncommon but may suggest the filter requires tuning.

Typical heading oscillation in a MEMS-gyro, magnetically compensated, system. Approximately 0.25deg peak-to-peak oscillation may be acceptable depending on the quality of the IMU. Note the general oscillation in the IMU data in this example.

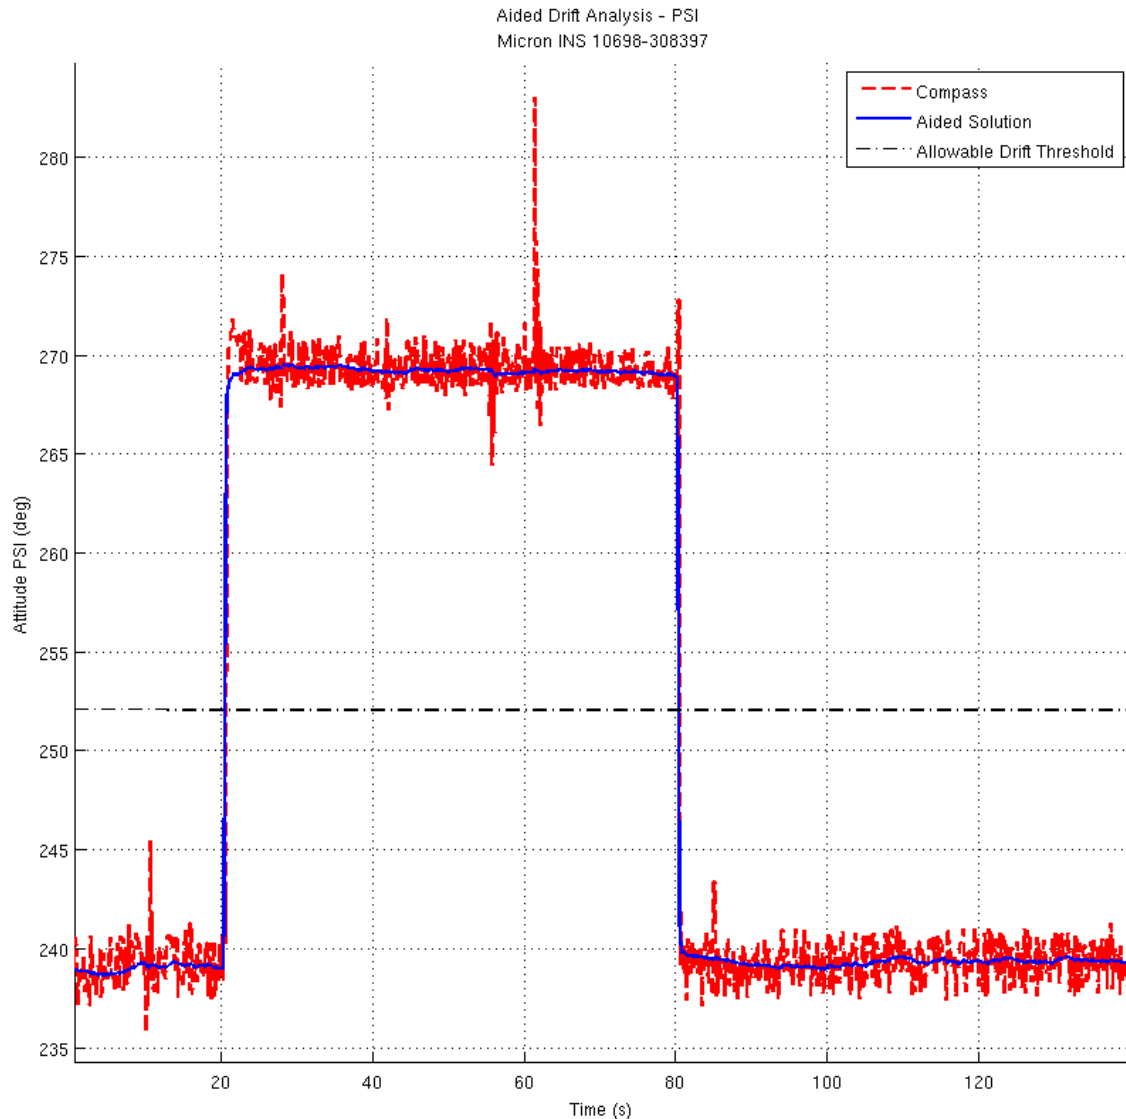
Illustration 2:

- **Heading overshoot and settling.** If the heading on a system is noted to overshoot and settle back to a value during a dynamic motion, the filter may be improperly configured for the IMU and aiding sensor combination. While some overshoot is expected due to the nature of the filter, this should not be noticeable to a user.

Reasonable heading solution (blue) performance during dynamic maneuvers.
